TIP 90 — Heavy Cuts Can Force the Mill Column out of Alignment/Sherline Products

A Cautionary Tale

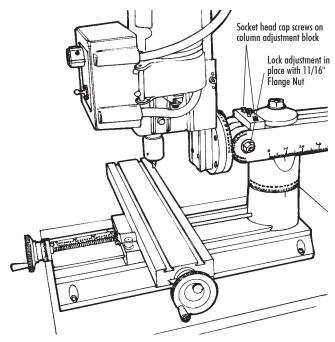
There is a possibility that the Z-axis column can be forced out of alignment on the 2000-series and the 5800-series Sherline mills while taking heavy cuts, especially under stepper motor operation (See Figure 1, refer to rotational axis #7). If this occurs, you will need to re-align the Z-axis column following these steps (see the Exploded view on page 2 for P/N references):

FIGURE 1—The axes of movement of a Sherline 8-direction mill.

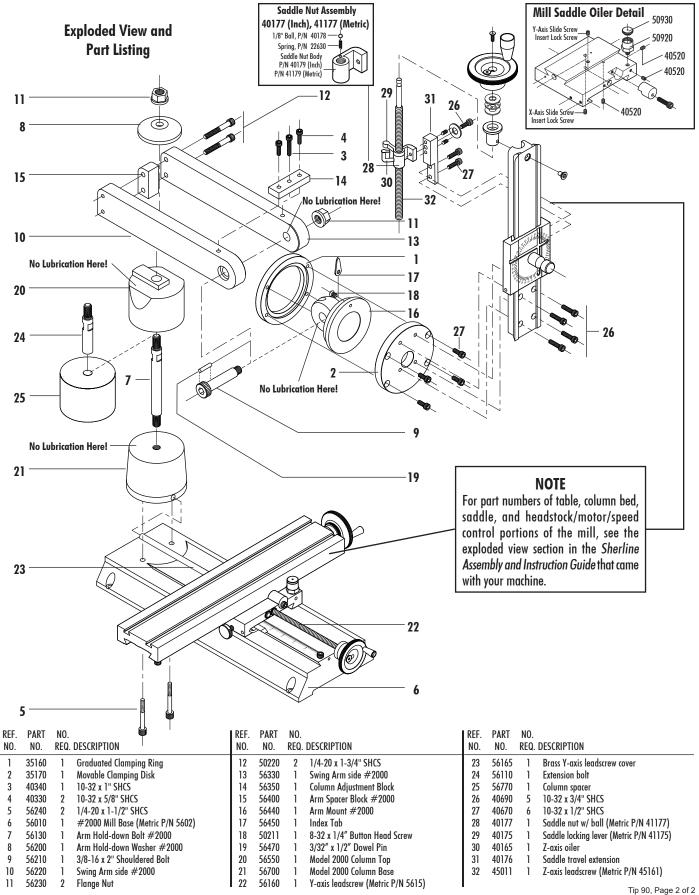
Sherline Model 2000 Mill Column

FIGURE 2—Shows the location of the flange nut and the SHC srews on the column adjustment block.

- 1. Loosen the flange nut (P/N 56230) located on the side of the ram arm (P/N 56330). (see Figure 2).
- 2. Square the Z-axis column bed per the instructions. https://sherline.com/Wordpress/wp-content/uploads/2016/01/2000inst.pdf
- 3. Tighten the flange nut to snug, for now, to hold the column in place.
- 4. Loosen one of the two 10-32 x 5/8" SHCS (P/N 40330) that sit atop the column adjustment block (P/N 56350). (NOTE: If these screws are not loosened prior to tightening the flange nut, you will not be able to fully lock down the flange nut.)
- 5. Tighten the flange nut down to full torque to lock the column in place.
- 6. Finally, re-tighten the 10-32 x 5/8" SHCS you loosened previously.
